30 Nov 2018 Alaska M7.0 Earthquake:

Anchorage Bowl Mobile Homes & Chimneys

Quick Report

Bruce F. Maison, S.E.

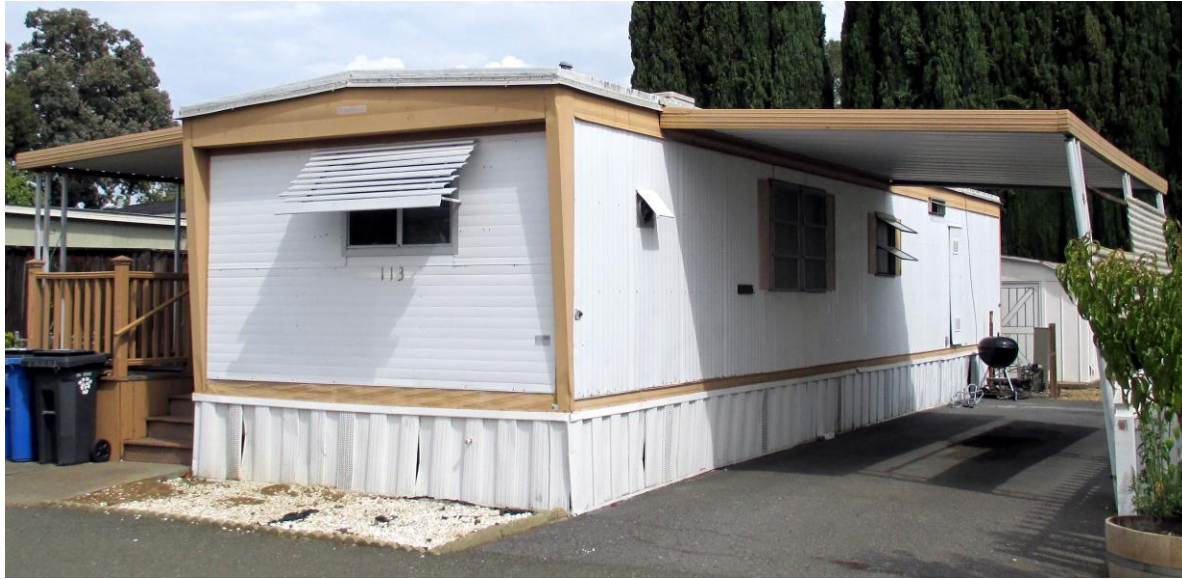
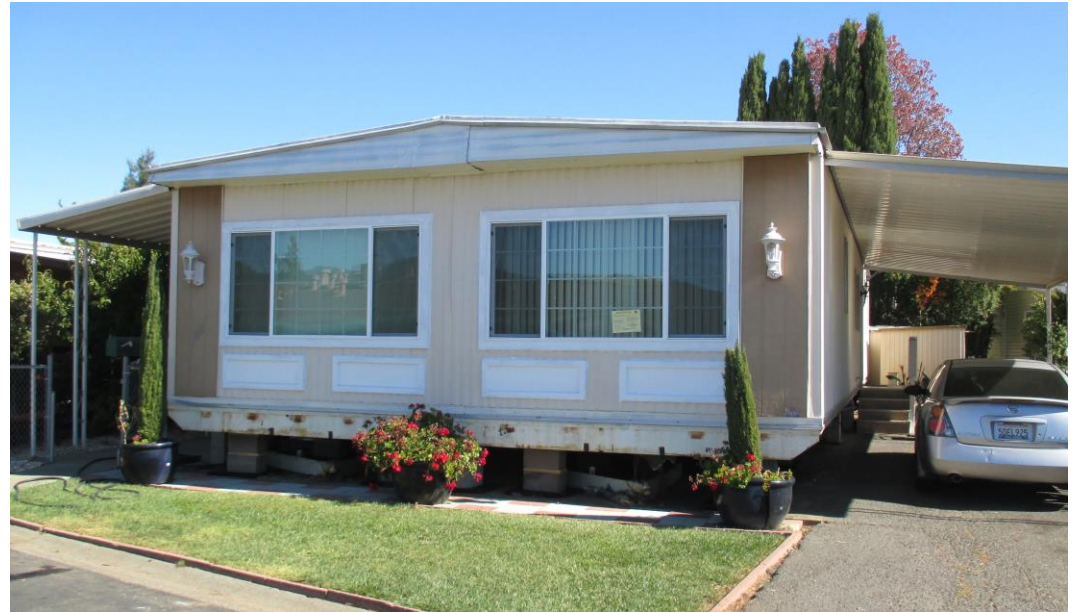
Anchorage Mobile Homes

Mobile homes in Anchorage

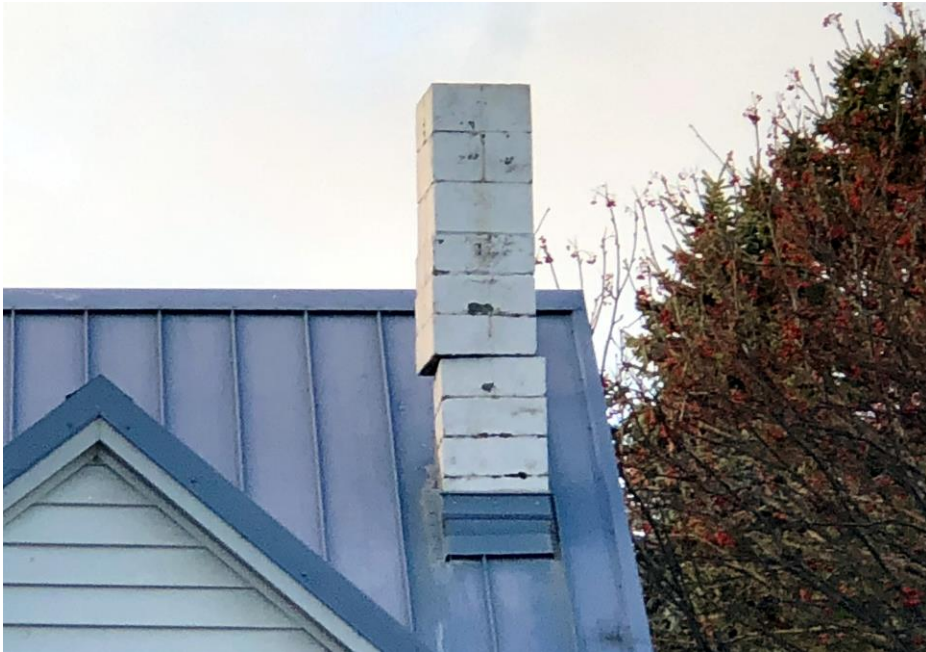
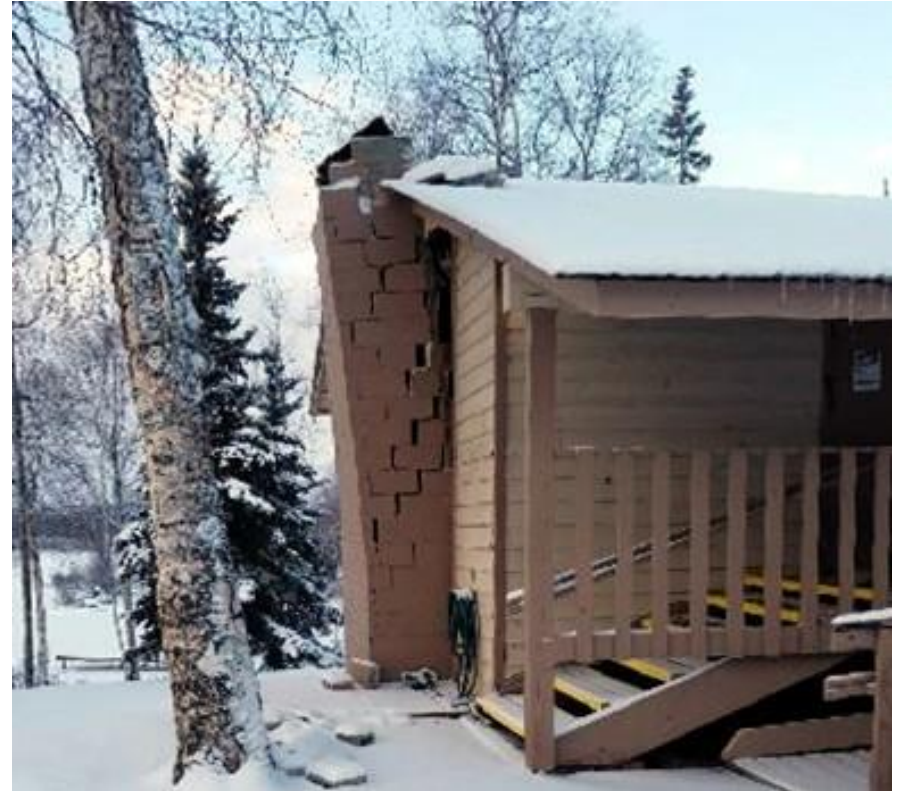
Anchorage Chimney Damage

- Plain masonry chimneys
