# Designing for Earthquakes in Anchorage: Site Response, Shear Wave Velocity, and Upcoming Changes in the Building Code

JOHN THORNLEY, PHD, PE – GOLDER ASSOCIATES USA

SEPTEMBER 2022

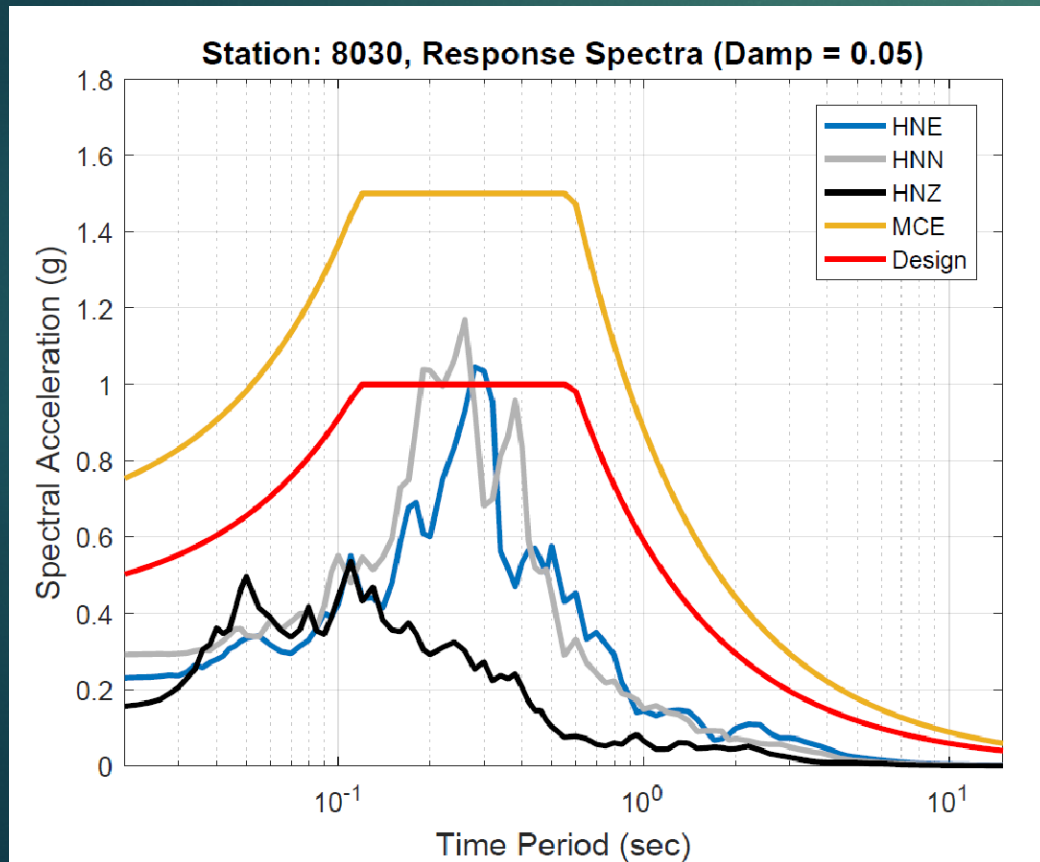
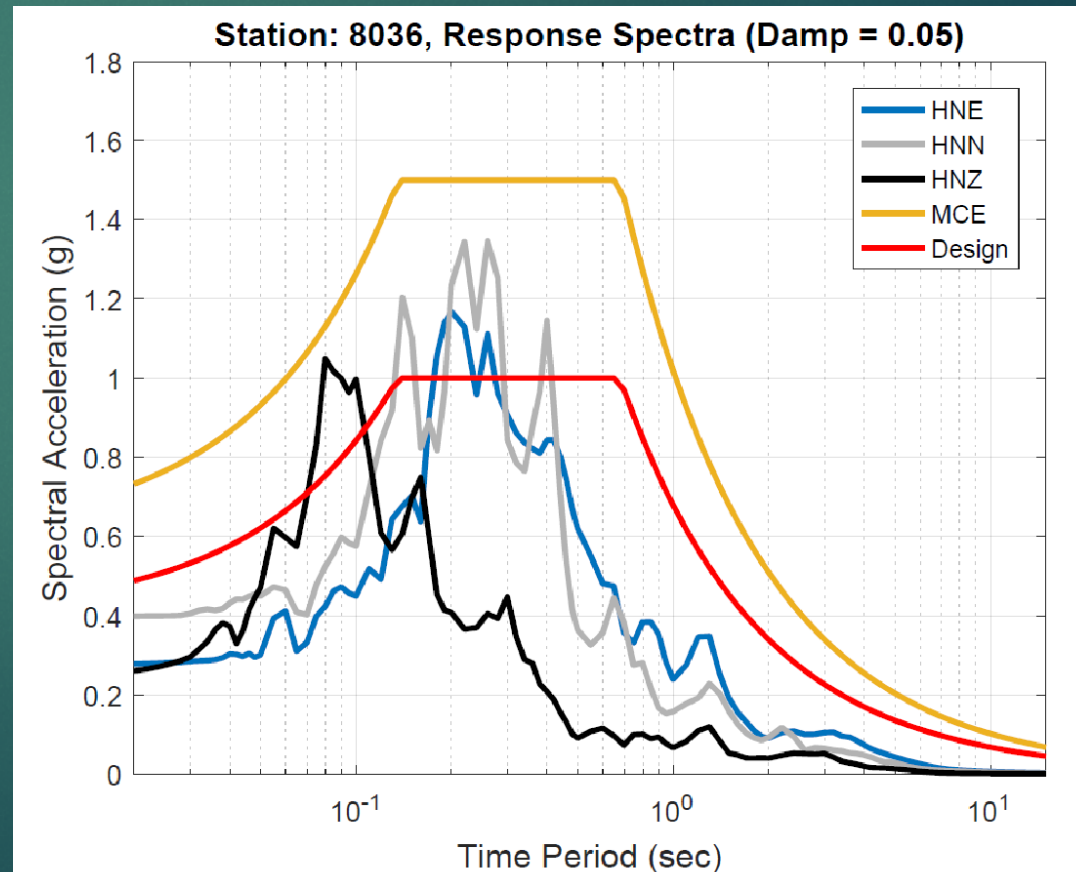
# Response Spectra from the 2018 Earthquake

▶ Station 8030 Tudor Police Station

▶ Station 8036 DOI Building – Lake Hood

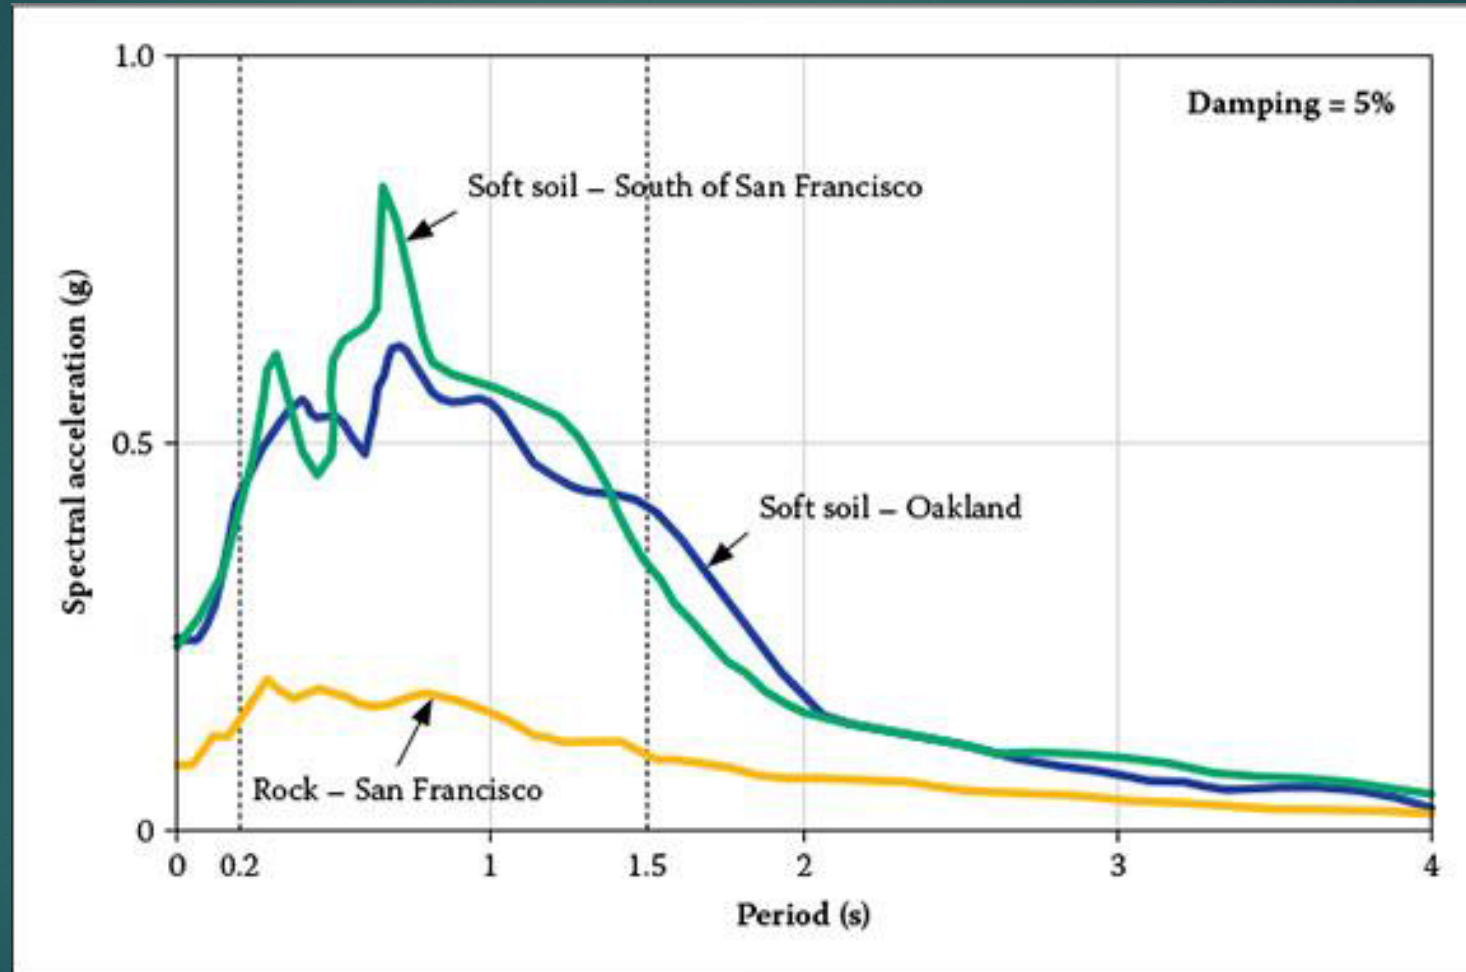
**Figure 12** Average soil-site spectra in Oakland and San Francisco areas with average rock-site spectra in the region during the 1989 Loma-Prieta earthquake (Dobry *et al* 2000; Dobry & Susumu 2000)

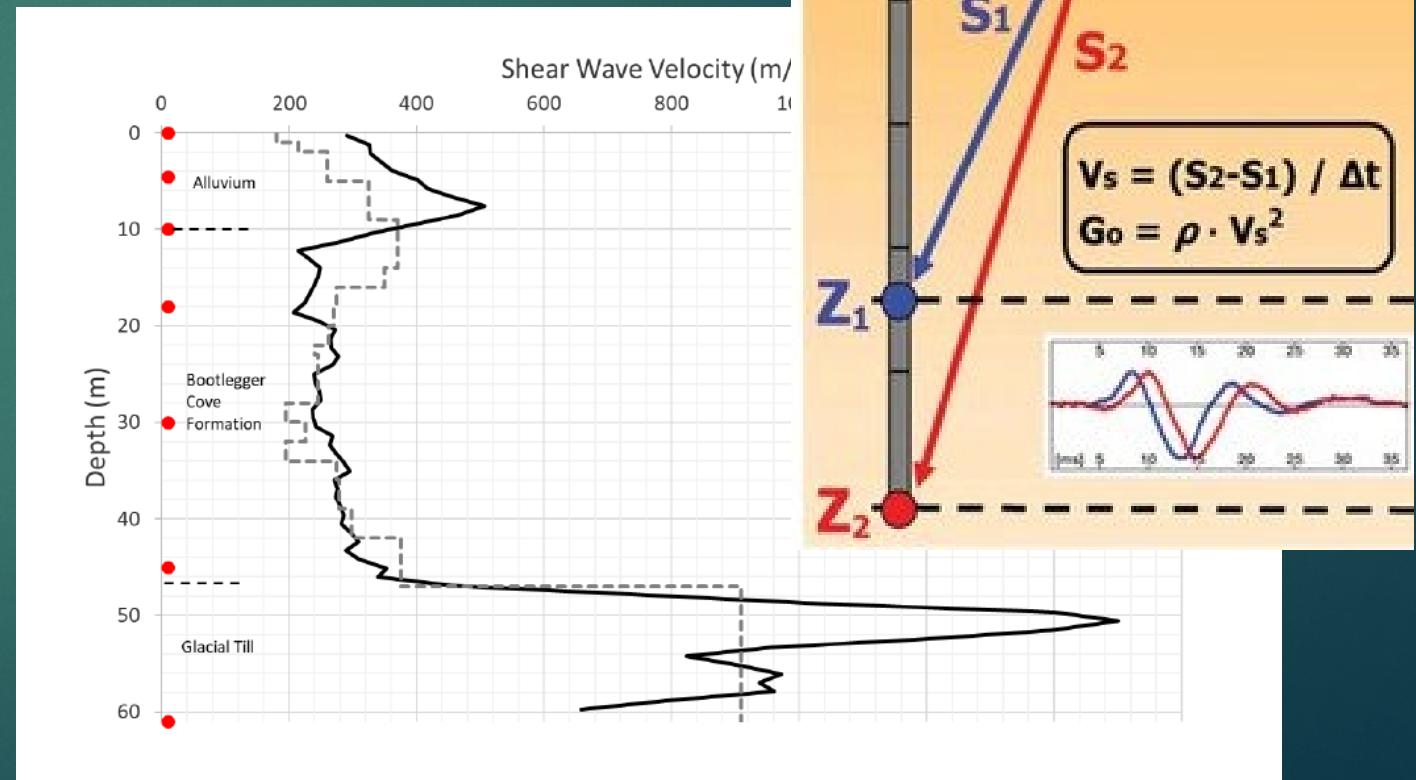
# Measuring Shear Wave Velocity

- ▶ In-Situ
  - ▶ Downhole
    - ▶ Cased hole
    - ▶ Suspension logging
    - ▶ Cone Penetration Testing
    - ▶ Cross-hole
- ▶ Surface
  - ▶ MASW, SASW
  - ▶ Seismic reflection/refraction

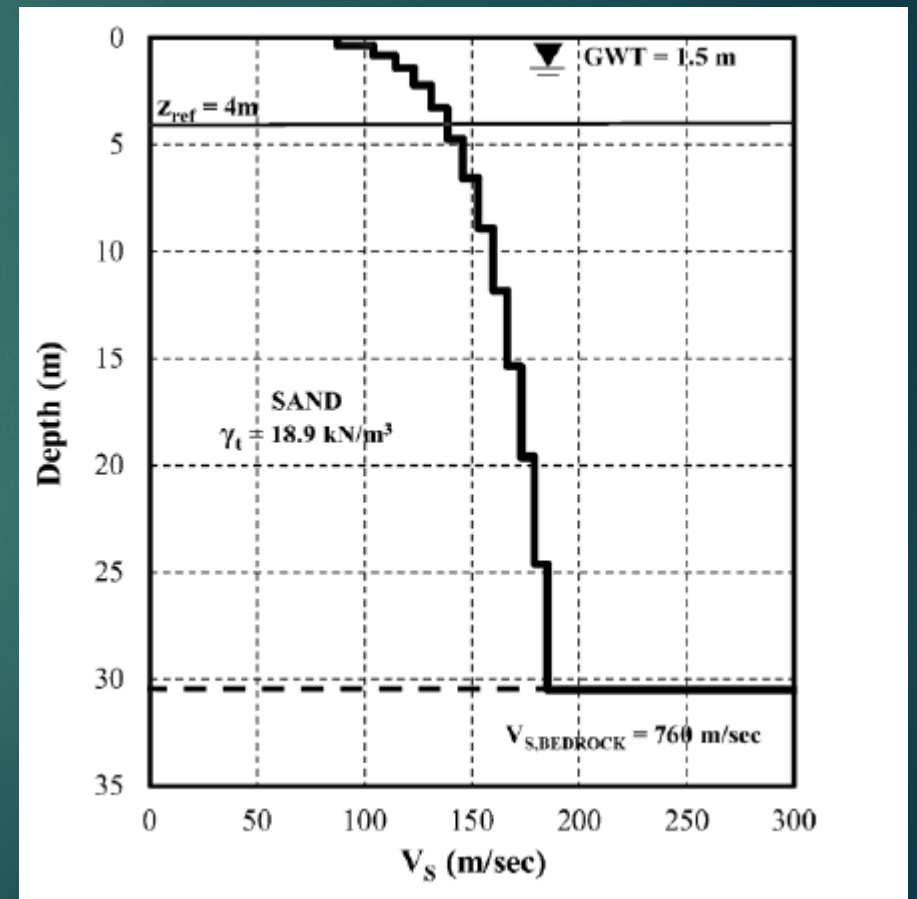
# The California Example

- ▶ Shear wave velocity increases with depth
- ▶ Engineering bedrock at 30m (100ft)

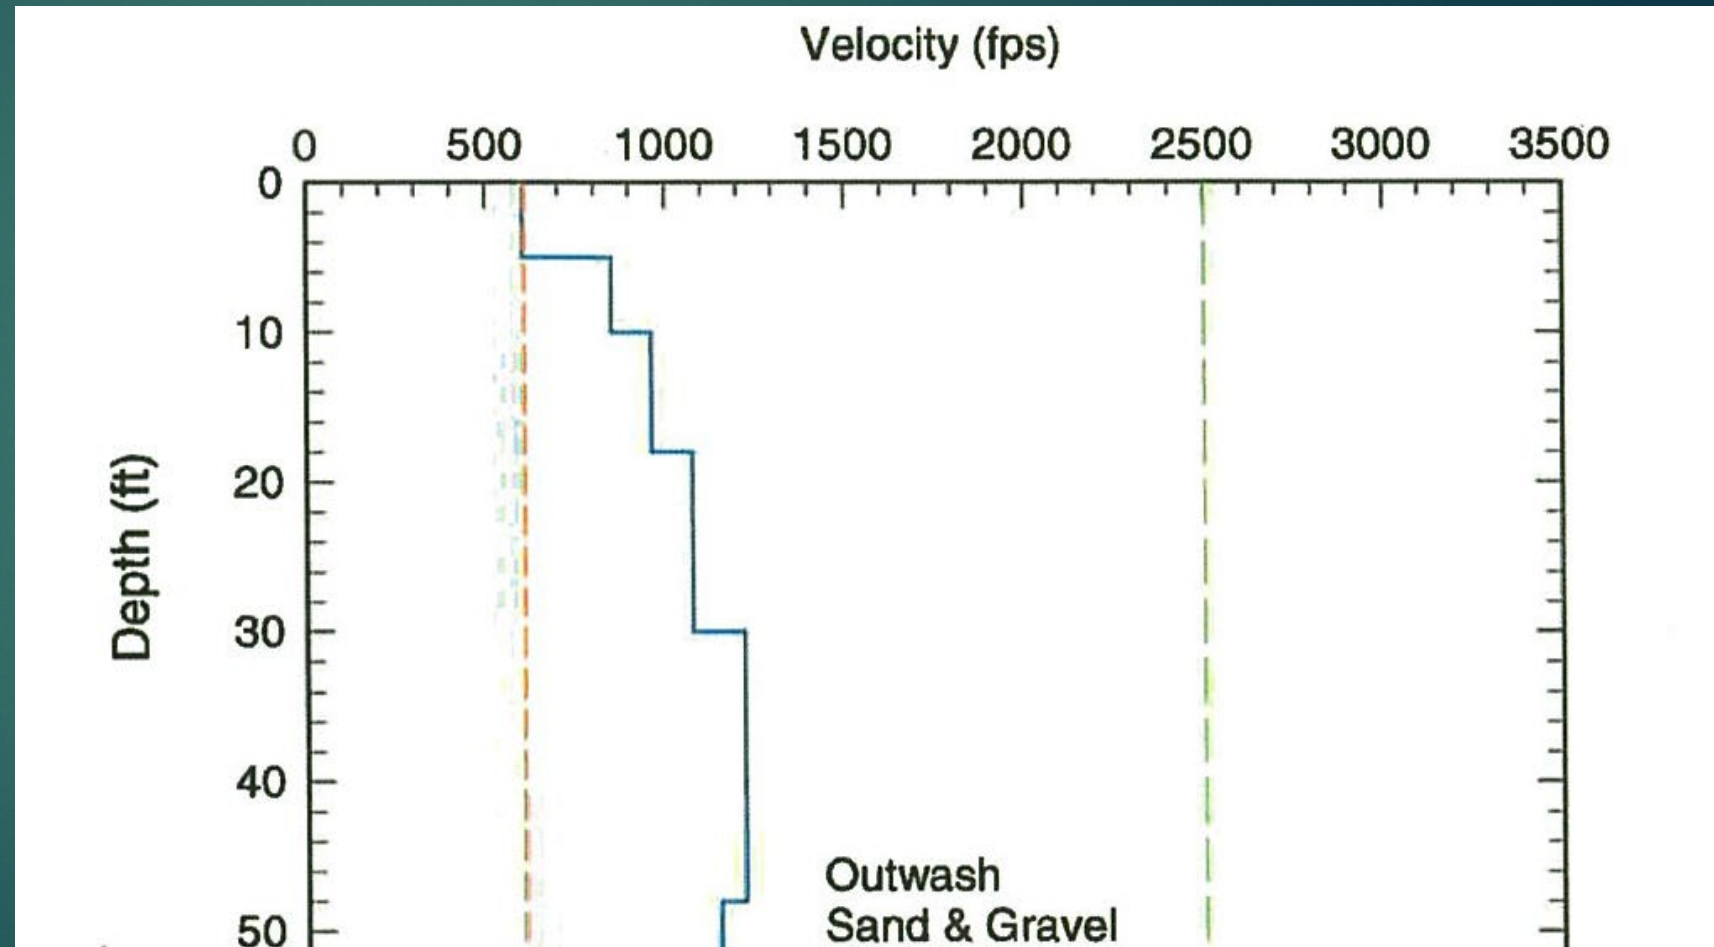
# An Example Closer to Home

- ▶ Downtown Anchorage

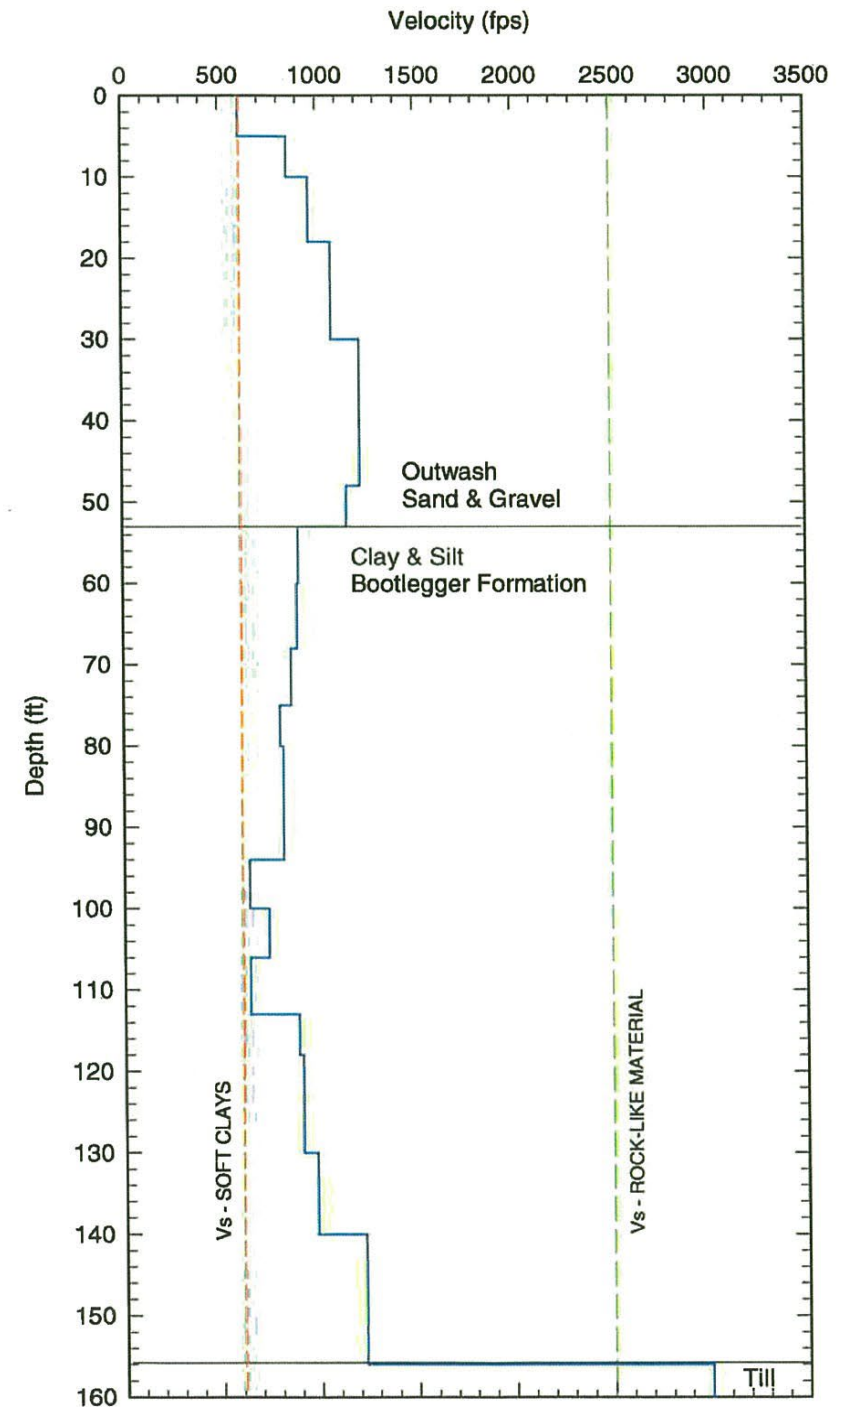
# The Full Profile

- ▶ Looking at the upper 50 feet alone would miss critical features that impact site response
- ▶ In Anchorage we see the underlying till as an “engineering” bedrock feature
- ▶ Bootlegger Cove Formation and other soft materials may be hiding at depth
